DOBSONVILLE DAM
CT 00210

PHASE I INSPECTION REPORT
NATIONAL DAM INSPECTION PROGRAM

MAY 1980

Identification No.:	Ct 00210
Name of Dam:	Dobsonville Dam
Town:	Vernon
County and State:	Tolland, Connecticut
Stream:	Tankerhoosen River
Date of Inspection:	7 November, 1979

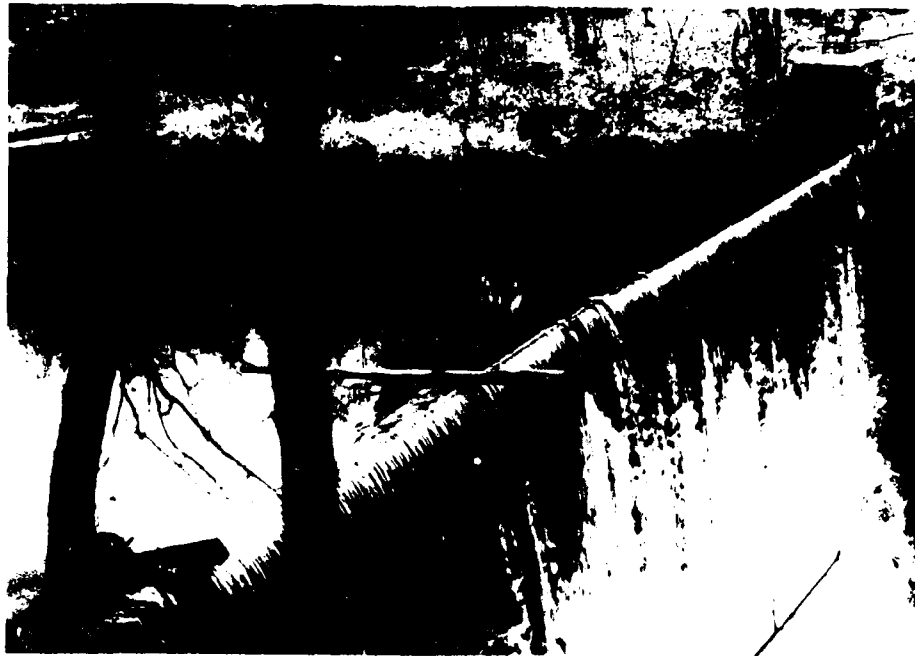
2) Downstream Face - The downstream face of the dam consists of a vertical stone masonry face, as shown in Photos No. 1 and No. 8. The condition of the stone masonry was largely obscured by the spillway flow, however the joints between the stones were observed to be unmortared (or the mortar had been displaced), as shown in Photos No. 8 and No. 9. Seepage through the unmortared joints in the stone masonry face was observed in several locations, as shown in Photo No. 8. The full extent of the seepage through the downstream face could not be determined because of the water flowing over the spillway.

PHOTO #1: Crest of dam from right abutment

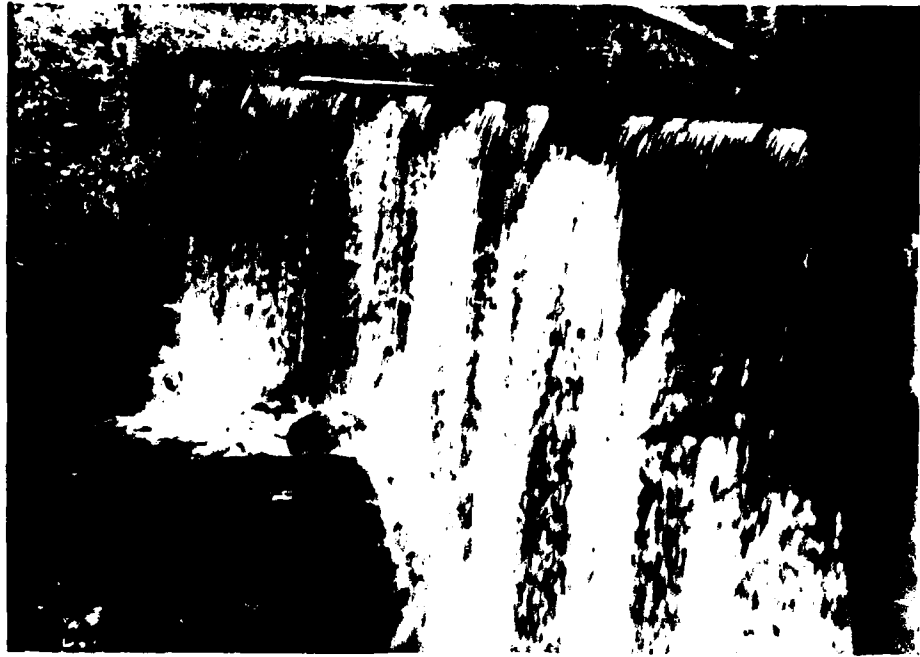
PHOTO #7: Downstream face of dam, from left abutment

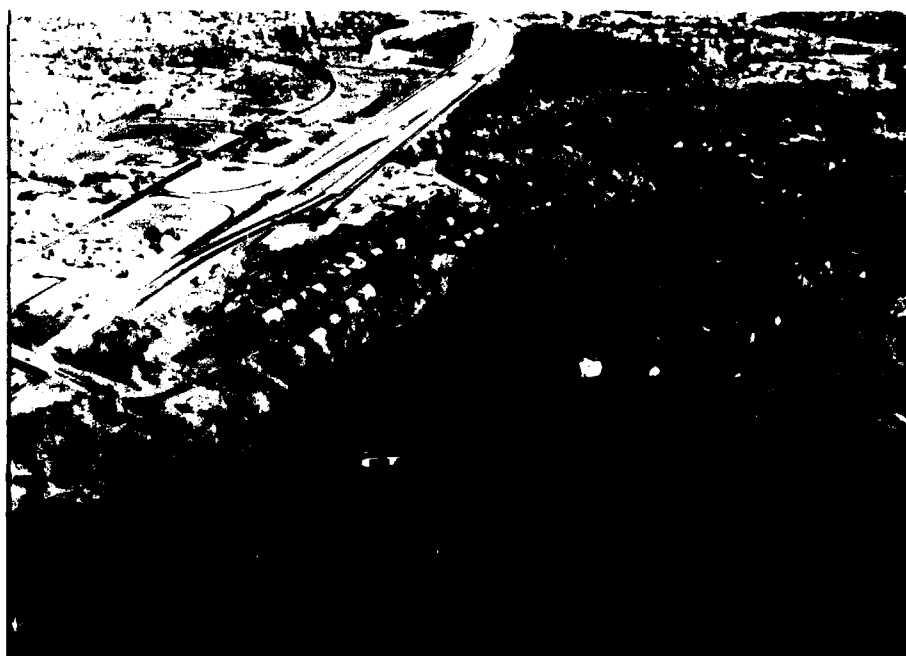
d. Reservoir Area. The perimeter of the reservoir varies from flat and landscaped to moderate and wooded. There is no evidence of slides or slope failures. No sediment deposits were observed above the water level of the reservoir (see Photo No. 12.) A highway bridge over the reservoir (upstream of the dam) does not significantly affect flow rates or stages at the dam.

PHOTO #12: Reservoir Area
